Bison Fuel Performance Code Fuel Fracture Validation

A thesis

Idaho State University

## Bison Fuel Performance Code Fuel Fracture Validation

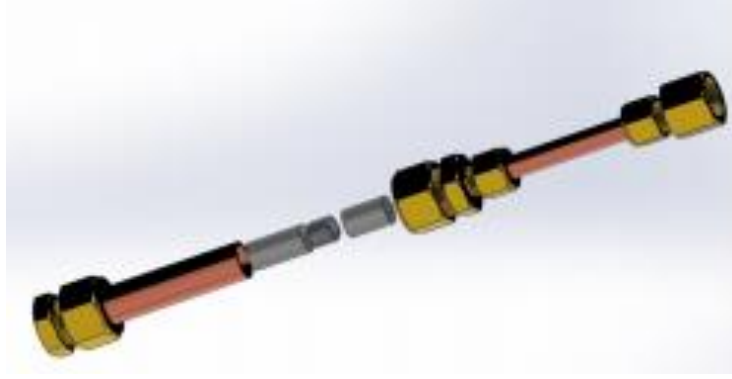
Volumetrically heating ceramic fuel materials outside of a reactor is very difficult to accomplish. The resistive heating experiments already discussed required relatively complex equipment. The temperature quenching experiments conducted at Texas A&M University had the advantage of using a simpler design. The basic experimental procedure was to heat a fuel pellet in a high temperature bath and, when it reached the desired temperature, to remove it from that bath and quickly submerge it in a lower temperature bath. Cooling would occur at the outer edge first and produce the desired temperature profile across the pellet if the high and low temperature baths were sufficiently different. The equipment requirements were few: a hot bath, a cold bath, and some way to move the pellet between the two. Copper tubing was used to hold the pellet and to protect the pellet from the baths. Commonly available sized copper tubing was used, rather than manufacturing a copper holder to fit the pellet. Therefore, the pellet didn't fit perfectly in the copper tube and the gap between pellet and tube was larger than optimum for heat transfer. So, the pellet was pushed to one side of the copper tubing. Fittings on either end of the copper piping made it leak proof. The setup for this experiment can be seen in figure 6.

Figure 6. Quenching Experiment Apparatus (Spencer et al., 2019)

A molten salt bath was used to heat up the pellet. The pellet was slowly allowed to reach thermal equilibrium with the molten salt so that stresses large enough to induce cracking were not introduced during this phase of the experiment. After the pellet reached thermal equilibrium, it is removed and immediately dunked into a cold bath. The cold bath was kept cold enough to cause the thermal gradient needed to induce cracking in the pellet.
