Physical Interaction Between Sodium and Standard Insulation

Jordan Harley

Master of Science in the Department of Nuclear Science and Engineering

Idaho State University

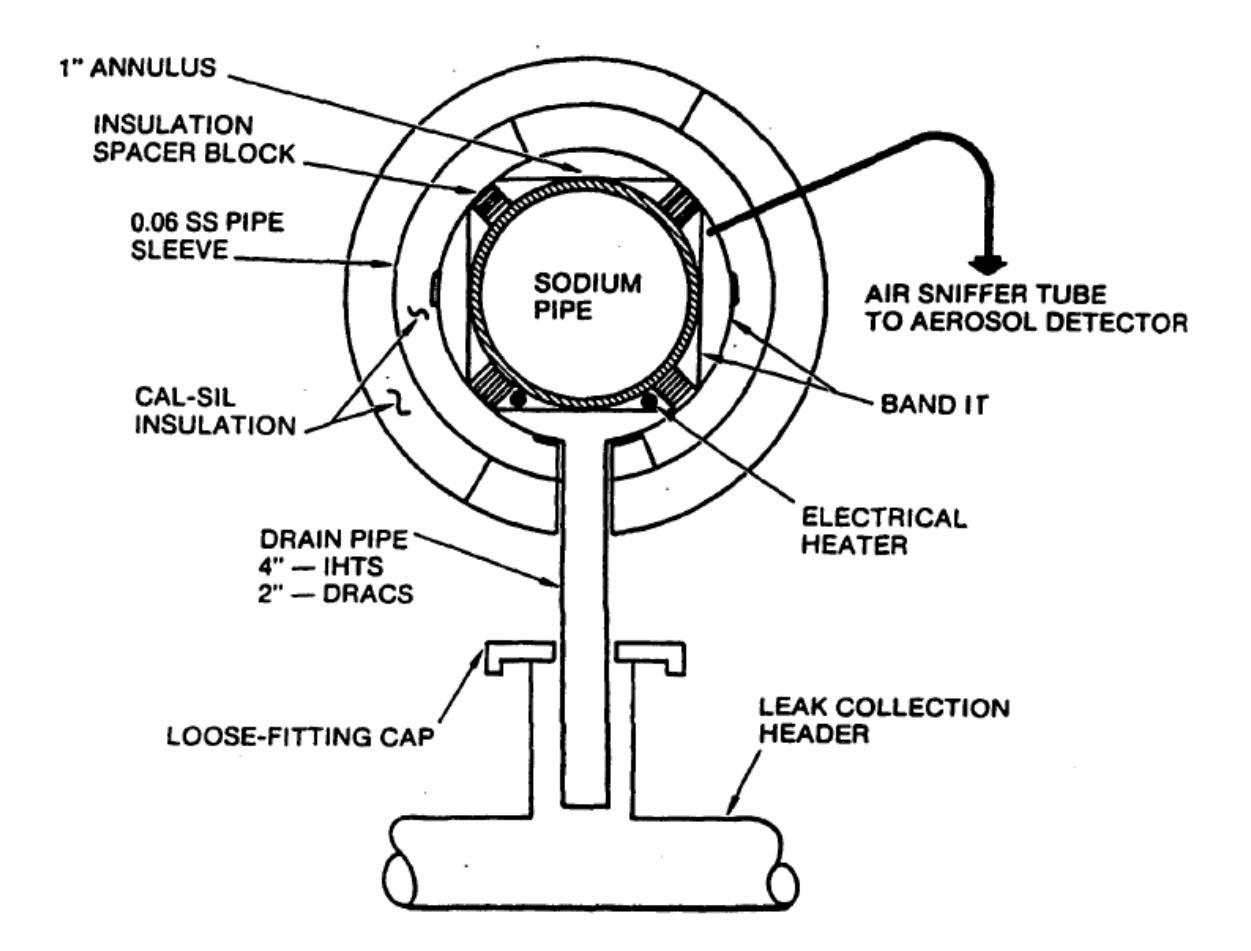
Figure 1. SAFR leak detection and drainage [12].

The Sodium Advanced Fast Reactor (SAFR) was a United States SFR designed as a coalition between Rockwell International Corporation and Argonne National Laboratory. Although it was never built, an in-depth design went into the passive safety of SAFR. Its sodium piping and leak detection system can be seen in Figure 1 [12]. The sodium piping is surrounded by an annular gas gap, followed by two layers of insulation and a metal sleeve. The gas gap allows space for electrical heaters and other instrumentation, such as an aerosol sniffer. There also exists a drainpipe that can capture any leaked sodium and transfer it into a storage tank via gravity. Since the SAFR reactor was never built, the leak detection it proposed is still only concept.

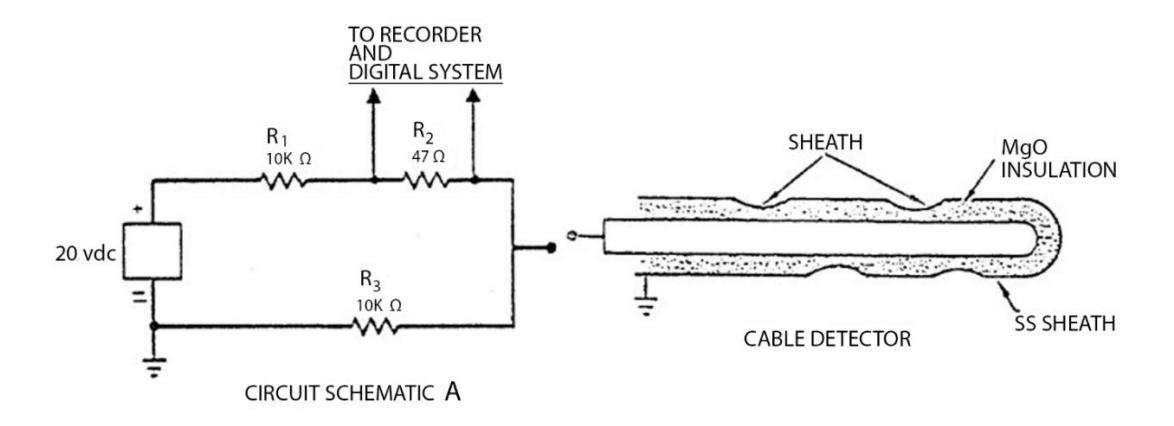
Figure 2. CRBR cable detector for liquid sodium leaks [13].

The Clinch River Breeder Reactor (CRBR) was a prototype reactor that was in its final stages of approval and had begun construction before being defunded due to political reasons. Sodium leak detection was a large part of the CRBR project and several different ideas came out of its design. Two of these leak detection designs were the 'cable detector' and the 'contact detector.' The cable detector was made from a stainless-steel coaxial cable insulated with magnesium oxide, and the outer sheath was grounded and perforated. Once liquid sodium

penetrates the outer sheath it causes a low resistance path to ground, increasing the voltage drop and sounds the alarm. This cable detector can be seen in Figure 2 [13].

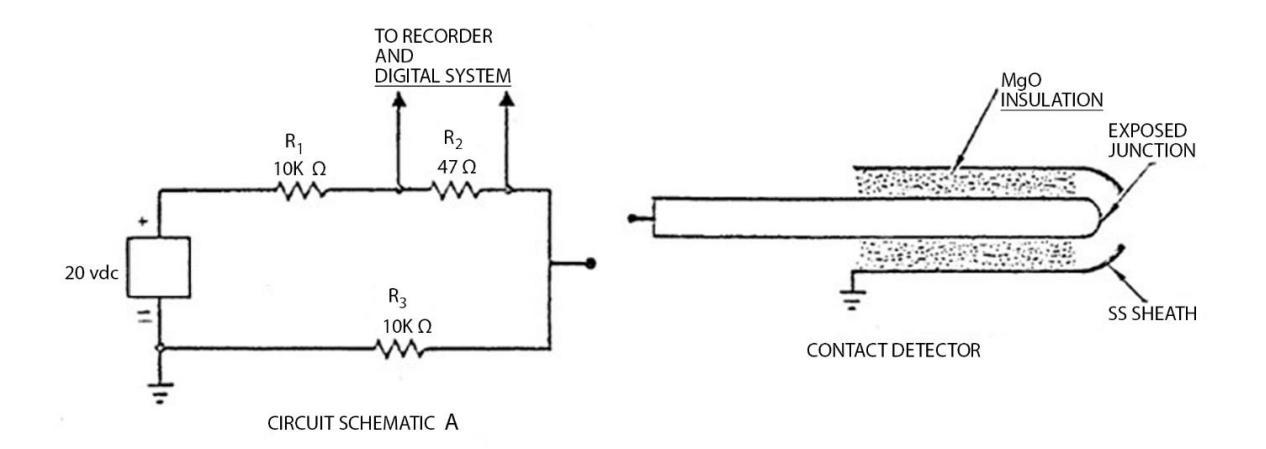
Figure 3. CRBR contact detector for liquid sodium leaks [13].

The contact detector is very similar to the cable detector in that it is stainless steel sheathed and insulated with magnesium oxide. The detector contains a coaxial cable joined as an exposed junction. When liquid sodium flows into the junction, it creates an electrical short between the junction and sheath and sounds the alarm. The contact detector acts more like a spark plug then the cable detector and can be seen in Figure 3 [13].

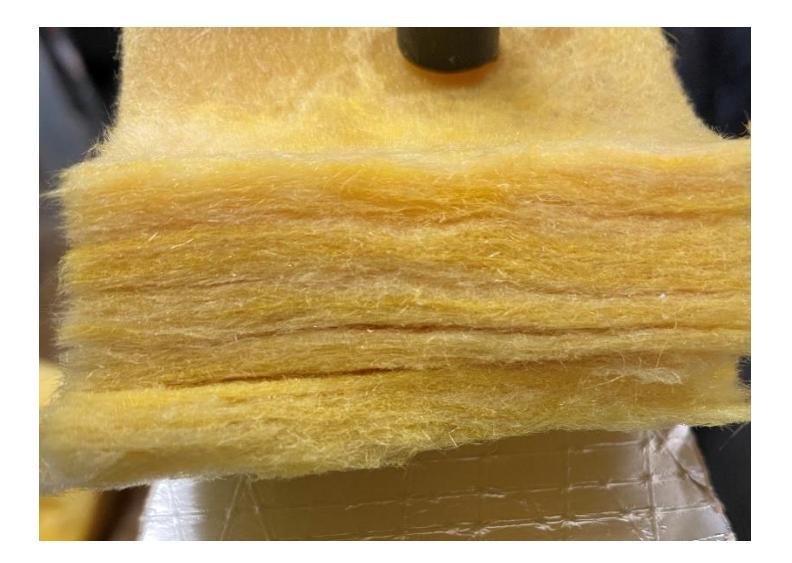
Figure 4. During the manufacturing process layers are formed in the insulation.

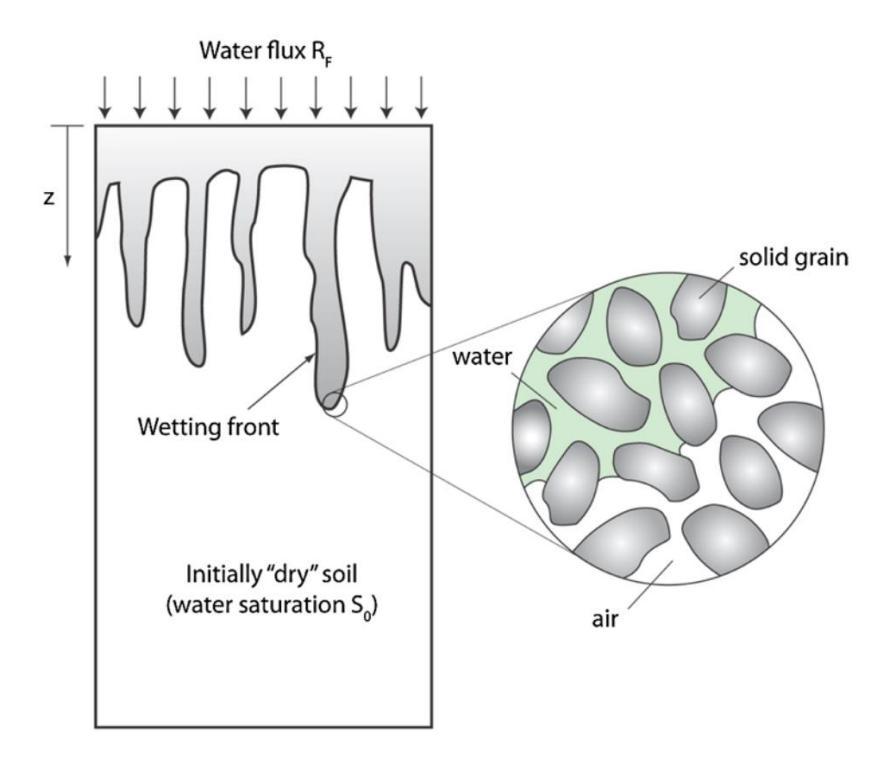
Figure 5. As water ingresses into the dry, porous soil, fingers are created as the water finds its path of least resistance [16].

The first experiment looks at a simulation of fluid flow through soil as performed by Cueto-Felgueroso and Juanes [16]. As it turns out, the invasive patterns seen inside of soil vary based on factors including a balance "between capillary, viscous, and gravitational forces at the pore scale" [16]. Tests have repeatedly shown that flows into homogenous soil, which behaves as a porous media, "takes the form of preferential flow paths (fingers)." It has been shown that when a fluid is introduced into a homogenous porous media, that a path of least resistance is found, and the fluid adheres to that. While Darcy's experiments did not look at flow patterns in porous media, others did and related these flow patterns using extensions to the Richardson's equation, which is "the traditional model of unsaturated flow" [16]. These extensions compensate for Darcy's law and considers water permeability in porous media to change with the proportion of water saturation currently in the media. Permeability is a quantification of how well a material allows fluids to pass through them. The extensions also help explain the phenomenon of gravity finger formation during fluid penetration. Figure 5 depicts fingers forming in dry soil, with S_0 indicating the initial water saturation of the media.

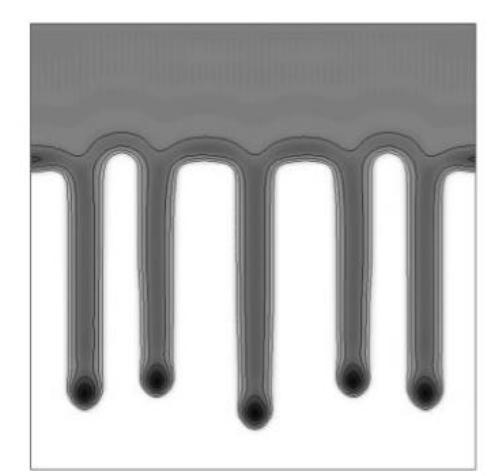
a. Long, pronounced fingers are formed as the water penetrates.

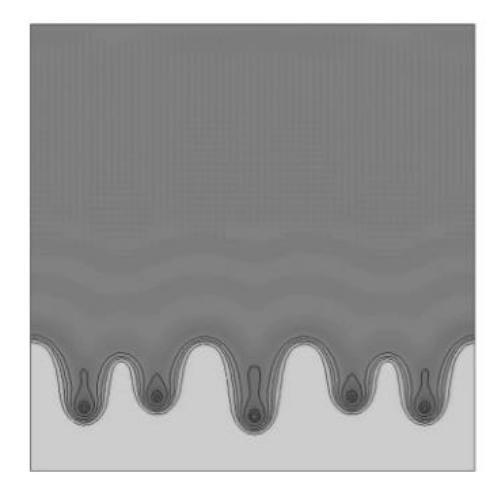
b. Short, less pronounced fingers are formed as the water penetrates.

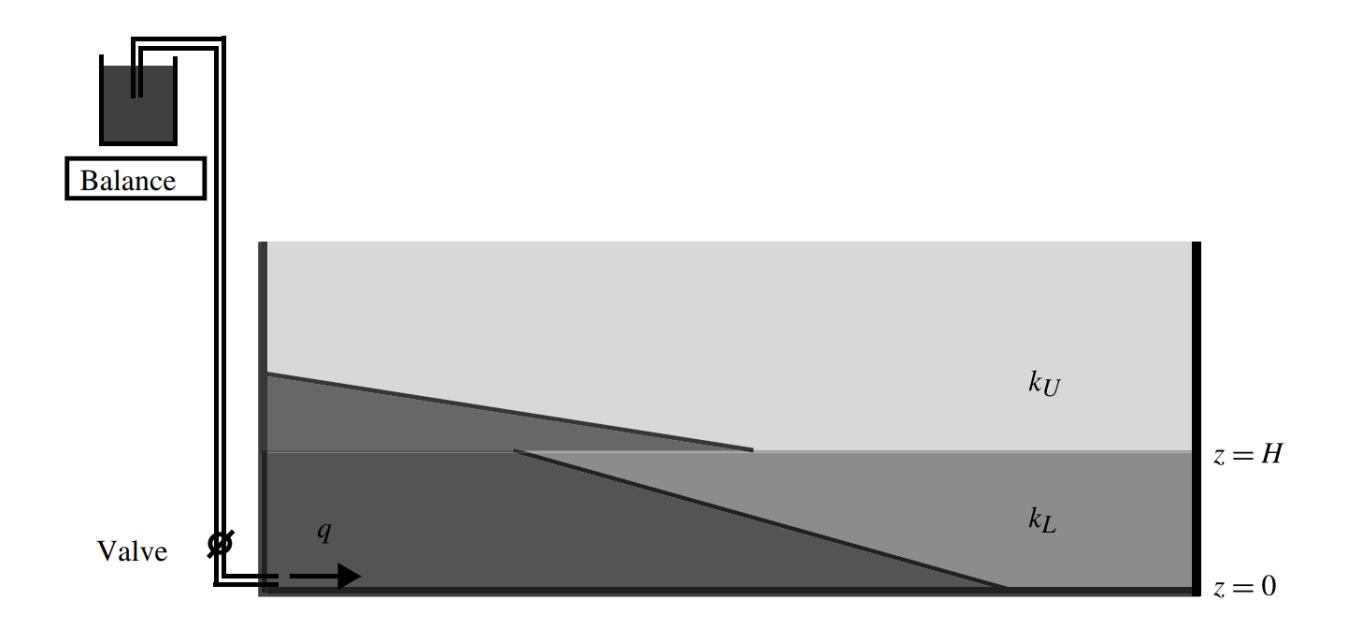
Figure 7. Depiction of experiment set up by Huppert et al [17]. Two layers exist, with the lower layer having a different permeability (k_U) than the upper layer (k_L) .

The second experiment performed by Huppert et al. looks at how differing permeabilities for media affect the flow of fluids [17]. This experiment was set up by layering two media one atop the other, each layer having a different permeability. The experiment can be seen in Figure 7, where k_U and k_L represent the permeabilities of the upper and lower regions, respectively. The different layers were made of glass ballotini (small beads of glass). Changing the bead size of the ballotini and making them larger positively changed the permeability of the layers.

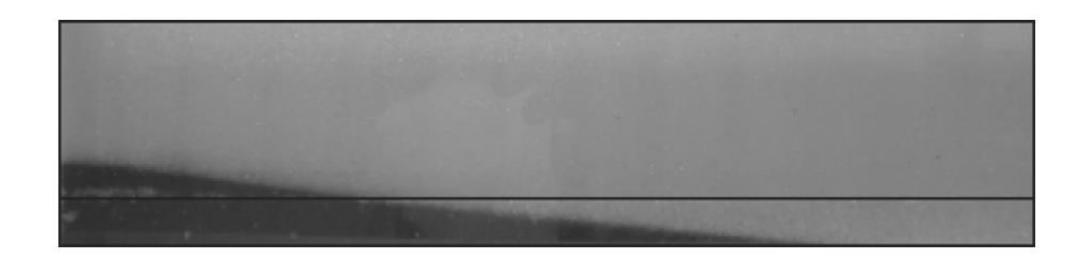
Figure 8. The lower layer is more permeable than the upper layer, causing the fluid to dominantly flow in this region along its base [17].

During the testing, Huppert et al. demonstrated that the differing permeability of the layers affected the way that the dense fluid saturated the media. When the lower layer was more permeable it was seen that the fluid flow focuses along the bottom of this layer. This can be seen in Figure 8. When the upper layer was more permeable, the fluid flow focuses on that layer. This is true at higher fluxes, even when the fluid was introduced into the lower, less permeable layer. It seems that the fluid finds the more permeable layer and then stays in that layer as long as it can, which is referred to as "flow focusing" [17]. One point of interest is when you look at how the fluid behaved after it has been allowed to flow in the upper, more permeable layer for an extended period of time. The fluid continued to flow along the base of this more permeable layer for a time. Gravitational effects eventually overcome the flow focusing effect and fingering began to appear in the lower, less permeable media. The upper layer flow pattern along with the eventual fingering can be seen in .

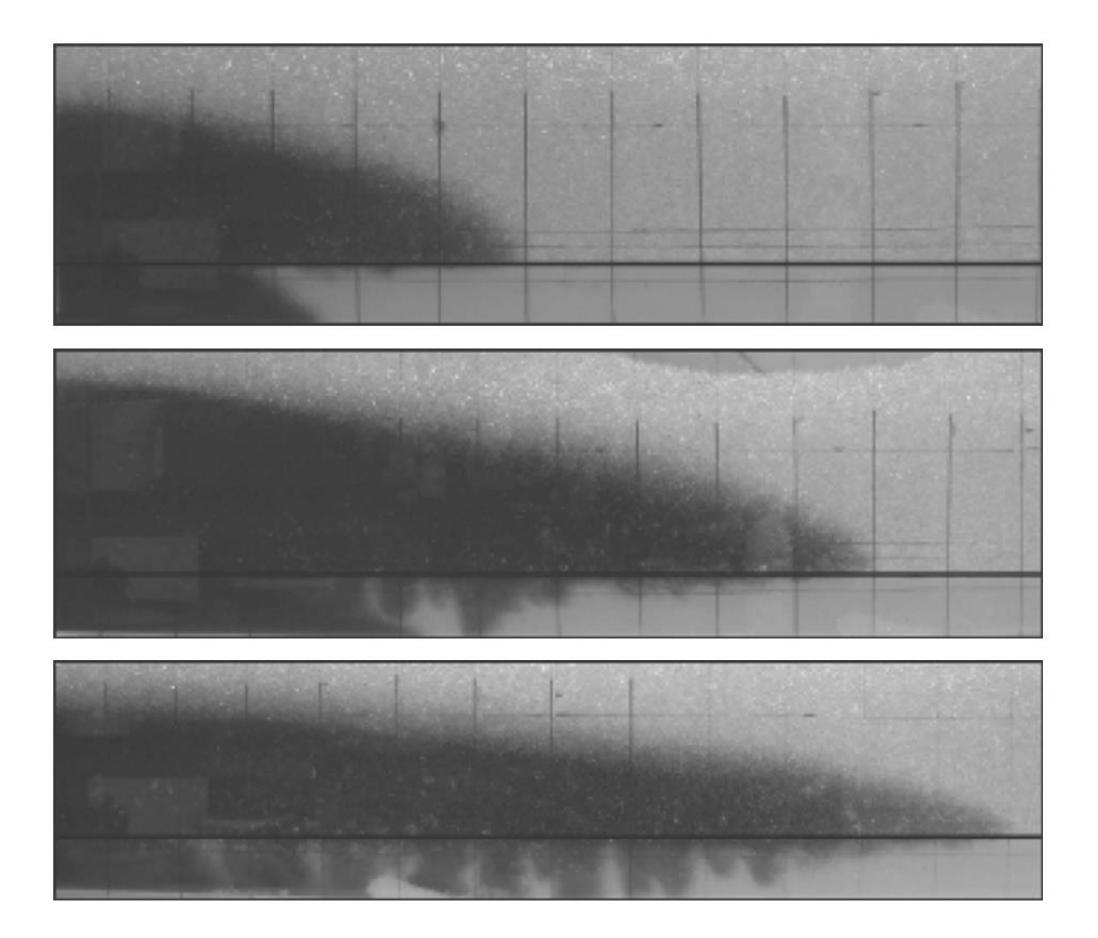
Figure 9. Dense fluid that was previously dyed is introduced in the lower, less permeable layer (top image). At higher fluxes the fluid finds the upper layer and focuses its flow at the base of this layer (middle image). Eventually, the fluid is overtaken by gravity and fingering begins to occur down into the lower layer (bottom image) [17].

This fingering effect correlated with the fingering found in the experiment performed by Cueto-Felgueroso and Juanes and exemplifies how a boundary of differing permeability can direct a fluid to flow horizontally along the bottom of a layer before the fluid invades into lower layers. In the testing hereafter, it will be shown how the water penetrated the insulation and would flow along a layer horizontally before it would start fingering and penetrate into lower layers, much like the fluid in this second experiment.

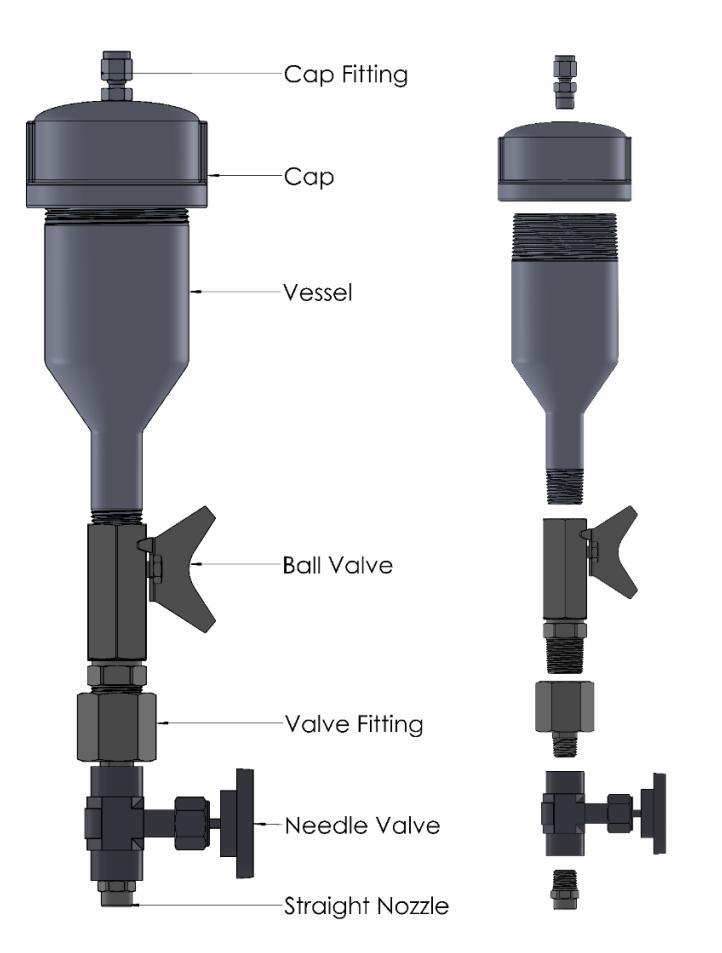
Figure 10. Completed drip assembly with each part being identified. An exploded view of the assembly shows how each part was connected.

The cap for the vessel helped enclose the system and have a more isolated environment for the heated sodium. It would prevent any unwanted objects from falling into the vessel, and also help prevent sodium from leaking out in the event the assembly fell over. The cap had a fitting placed into its top to provide an orifice to insert a thermocouple. The thermocouple was used to measure the temperature of the sodium inside of the vessel. The cap fitting also provided a way for argon gas to flow into the vessel during testing. This would help prevent suction from occurring inside the apparatus, allowing the sodium to flow more easily and consistently. The cap did not originally have a threaded hole to attach the fitting to, so an 1/8-inch NPT threaded hole was tapped into the center of the cap.

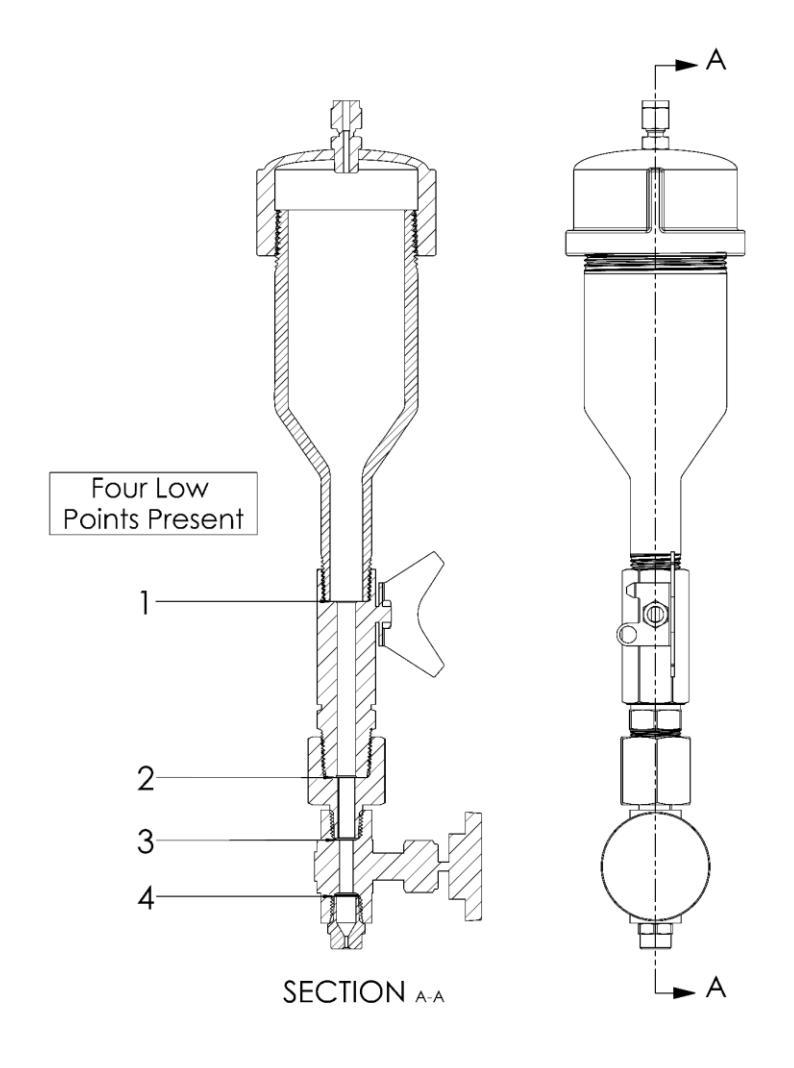
Figure 11. Cut-away view of the sodium drip assembly. Four low points are depicted in the assembly, which represent possible locations of sodium build-up after the sodium was drained.
The drip assembly was heated via a silicone pipe heating tape, measuring 4 feet long and a $\frac{1}{2}$ inch wide. The heat tape maximum temperature rating was 232 °C (450 °F) and contained a temperature controller box. This model of heat tape was chosen because it was flexible and could fit around the odd-shaped drip assembly while still providing maximum heat load to the surface.

Two valves were used to provide an extra barrier and prevent unwanted sodium drippage and were connected through the valve fitting. The upper valve was a ¹/₂-inch ball valve that was mainly used as an on/off switch for the liquid sodium. The lower valve was a ¹/₄-inch needle valve that was used as a gradual open/close switch to achieve a more precise and accurate drip rate than a simple ball valve, while also reducing unwanted releases of sodium. A straight nozzle was chosen to facilitate a solid stream drip pattern. The nozzle had a small orifice diameter of 0.06 inches which helped control the drip rate. The experiment was designed to remove as much sodium as possible through gravity drainage when the experiment was over. This was done by using a cone shaped sodium vessel and making the entire assembly vertical. However, horizontal surfaces were present at each of the connection points from the vessel downward. These horizontal surfaces act as hydraulic low points and will retain residual sodium even when the bulk sodium has been drained. A depiction of these low points can be seen in Figure 11. The surface area of these horizontal points is minimal but should still be considered when taking apart the assembly for cleaning.

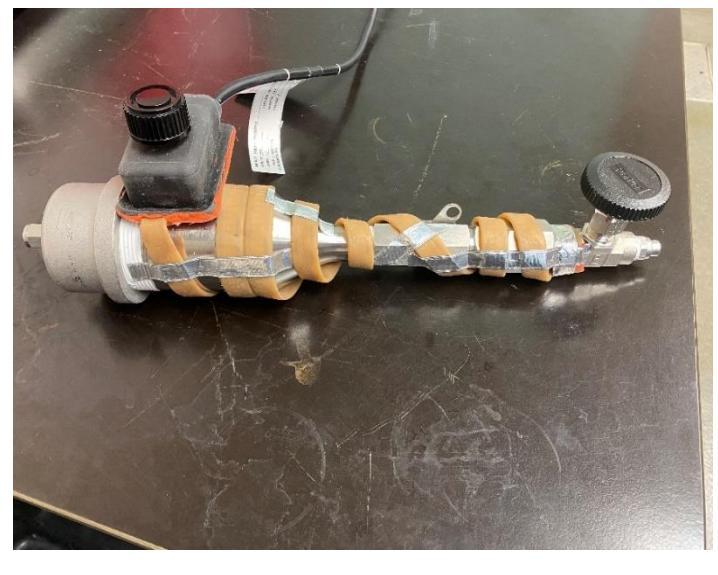
c. The heat tape was helically wrapped around the final assembly and secured using aluminum tape.

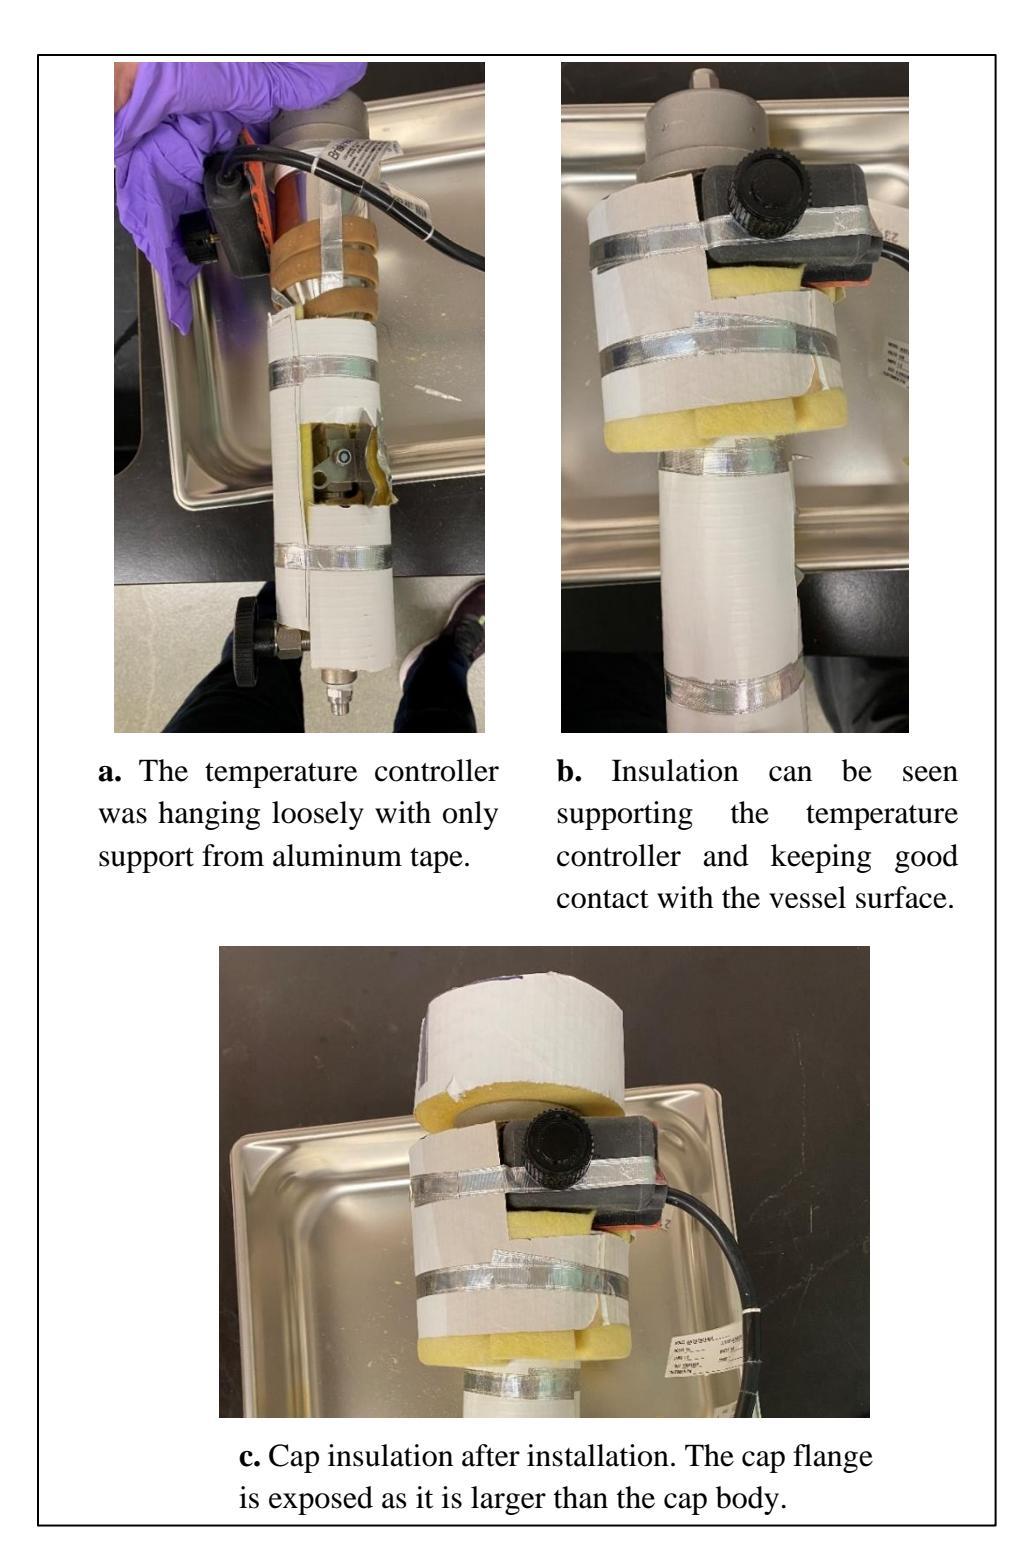
Figure 14. Installing the 2-inch pipe insulation used for the vessel and cap. The insulation also acted as a support structure to keep the temperature control box in place.

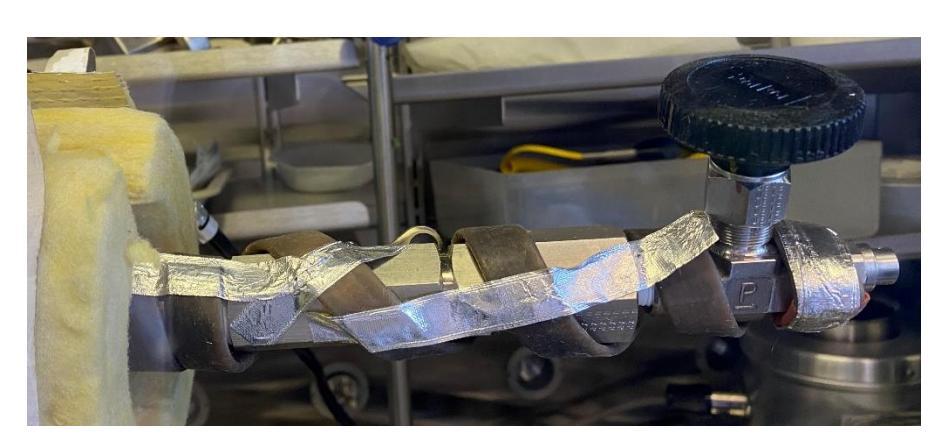
a. The heat tape was re-wrapped so its end was surrounding the bottom half of the needle valve.

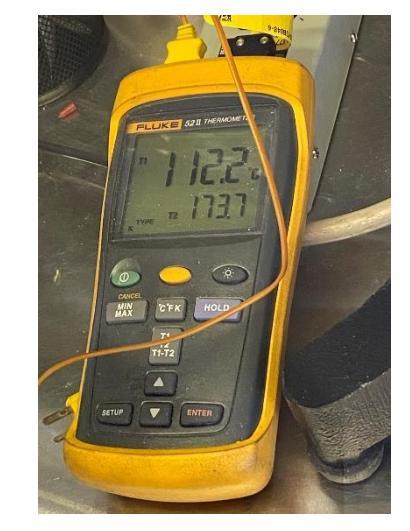
c. Nozzle temperature reached 112 $^{\circ}$ C with a steady heat tape temperature of 173 $^{\circ}$ C.

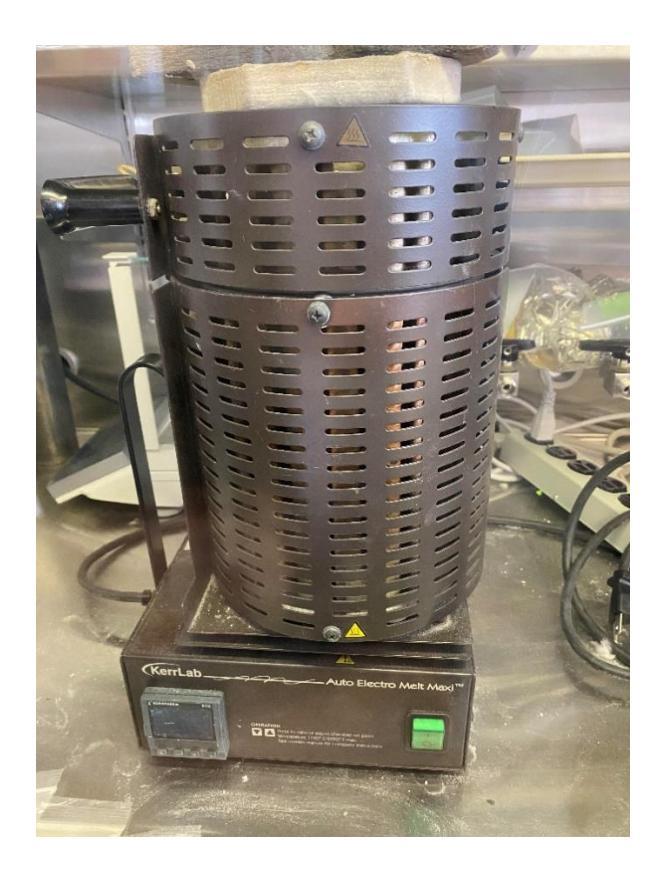
Figure 17. A depiction of the jeweler's furnace used in these experiments.

Due to the challenges with maintaining sodium droplets in a molten state once they dripped from the custom assembly, an alternate experimental design was developed that would keep the sodium in a molten state for an extended period of time. This experiment used a jeweler's furnace to heat both the sodium and insulation sample to relevant temperatures, while providing a longer window for the molten sodium to interact with the insulation. The jeweler's furnace was a large Kerr Lab Automatic Maxi Electro-Melt [18] with a maximum temperature rating of 1120 °C. The furnace was digitally controlled with a Johnson 3216 controller. A depiction of the jeweler's furnace can be seen in Figure 17. A large graphite crucible served as both the sample holder and heat transfer medium for the furnace. A smaller alumina crucible was used as the container vessel for the insulation sample, and was lined with a stainless-steel foil sheath. The foil provided a barrier between the sodium and insulation and the inner crucible, preventing any contamination between the molten sodium and the alumina or graphite crucibles.

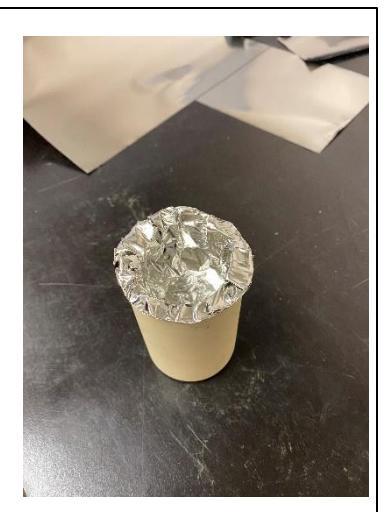
c. The foil was pressed to form a liner inside the crucible.

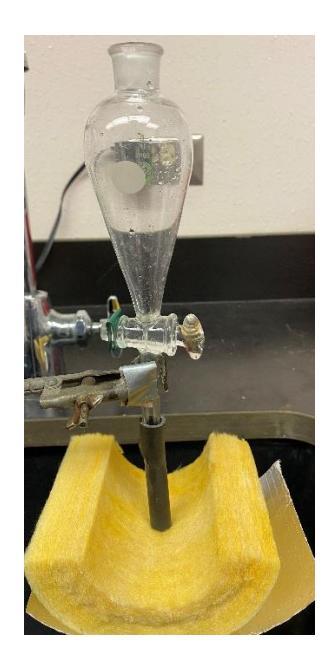
Figure 21. General set up of a cut piece of insulation resting underneath a volumetric burette with its attached tube. Insulation specimens were placed with their center point beneath the burette.

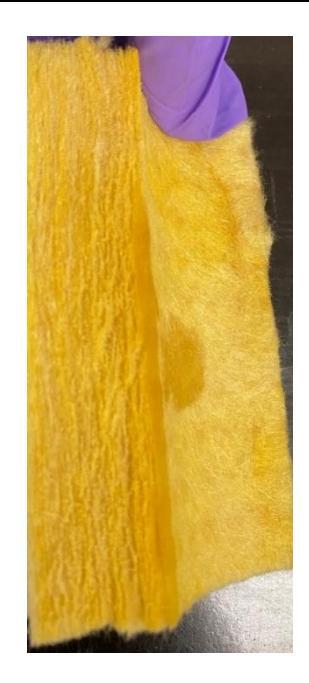
b. Water penetrated 0.12 inches vertically into the insulation then exclusively travelled horizontally along the layers path.

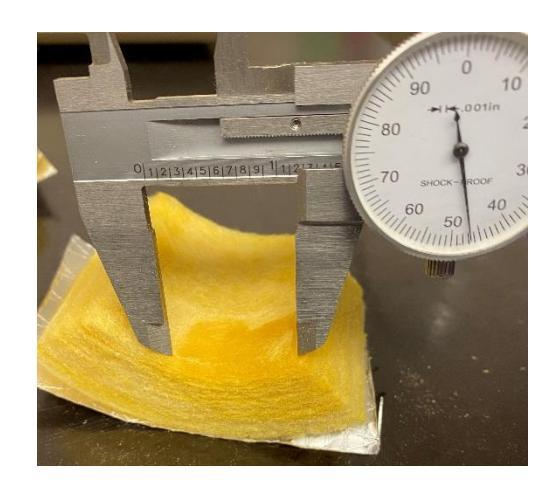
c. Water spread 1.15 inches along insulation curvature.

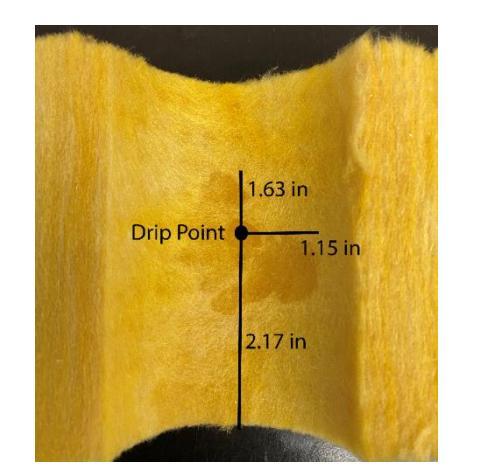
d. Water at first diffused in a circular pattern (seen at drip point) then quickly traveled horizontally to the front edge.

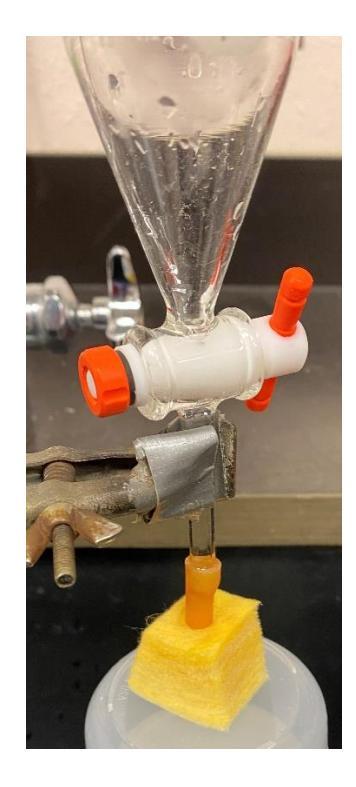
Figure 23. Depiction of the test set up using a 1-inch cube of insulation.

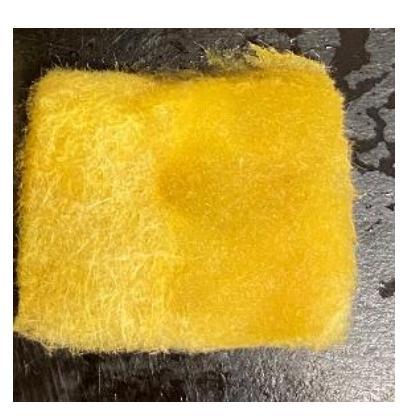
a. Water diffused into roughly half of the top layer before penetrating deeper.

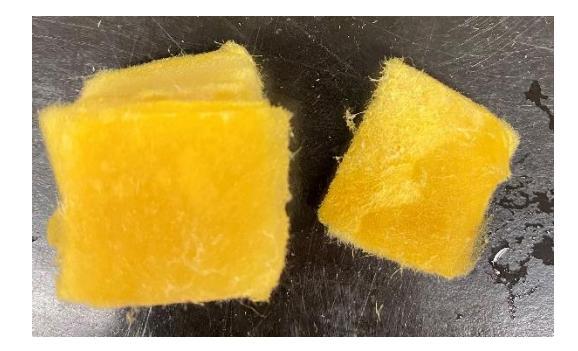
c. Water diffuses along the entirety of the wet layer 0.11 inches from the top surface.

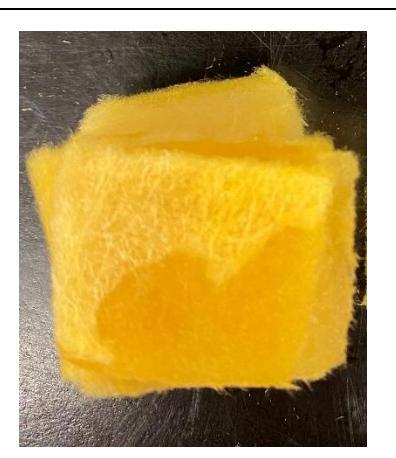
b. Water continues to penetrate deeper into the insulation.

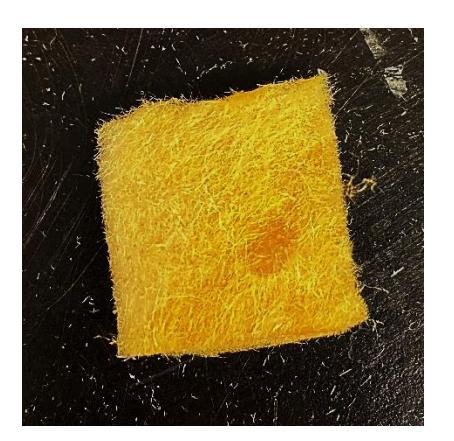
d. Beneath the wet layer the tip of a finger is being manifested as the water penetrates deeper into the insulation.

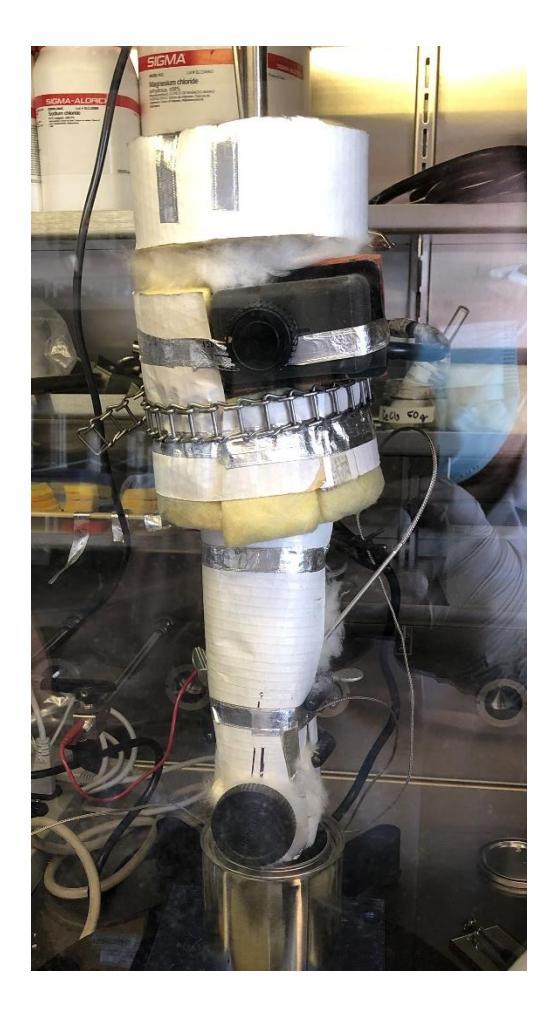
Figure 26. The drip assembly after quartz wool was applied to insulate the exposed needle and ball valves.

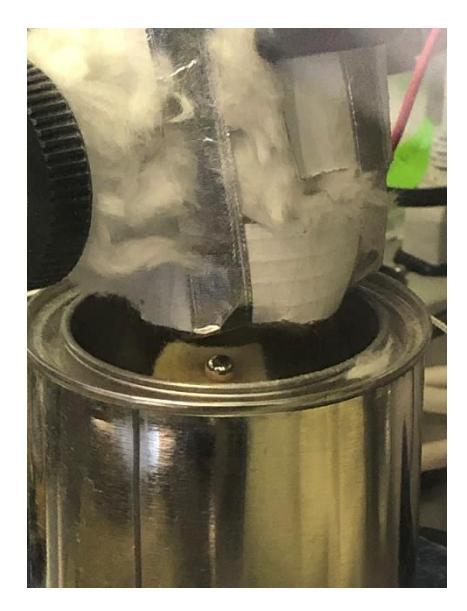
a. The first two droplets combined on top of the insulation and had a silver sheen before they solidified.

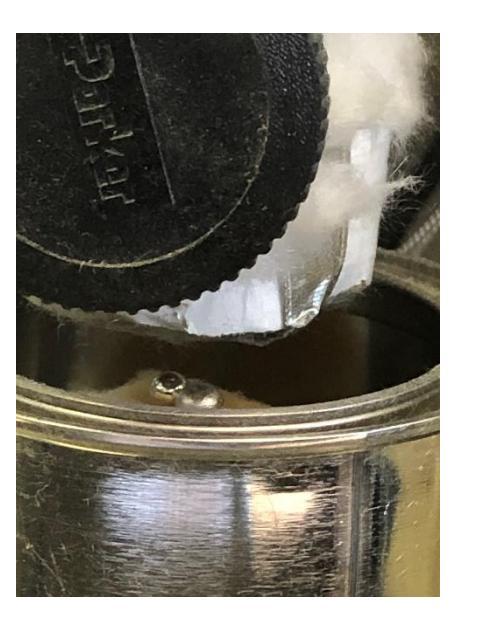
b. The third droplet did not combine with the first two. The smaller, shiny droplet is the third one that had not solidified yet.

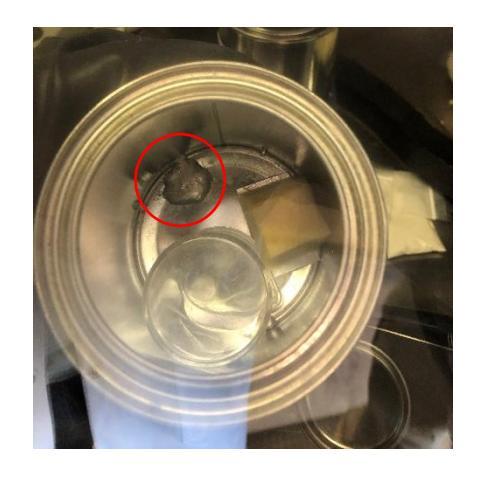
c. A small puddle of solidified sodium was found at the bottom of the test paint can indicating sodium had been flowing straight off the insulation sample.

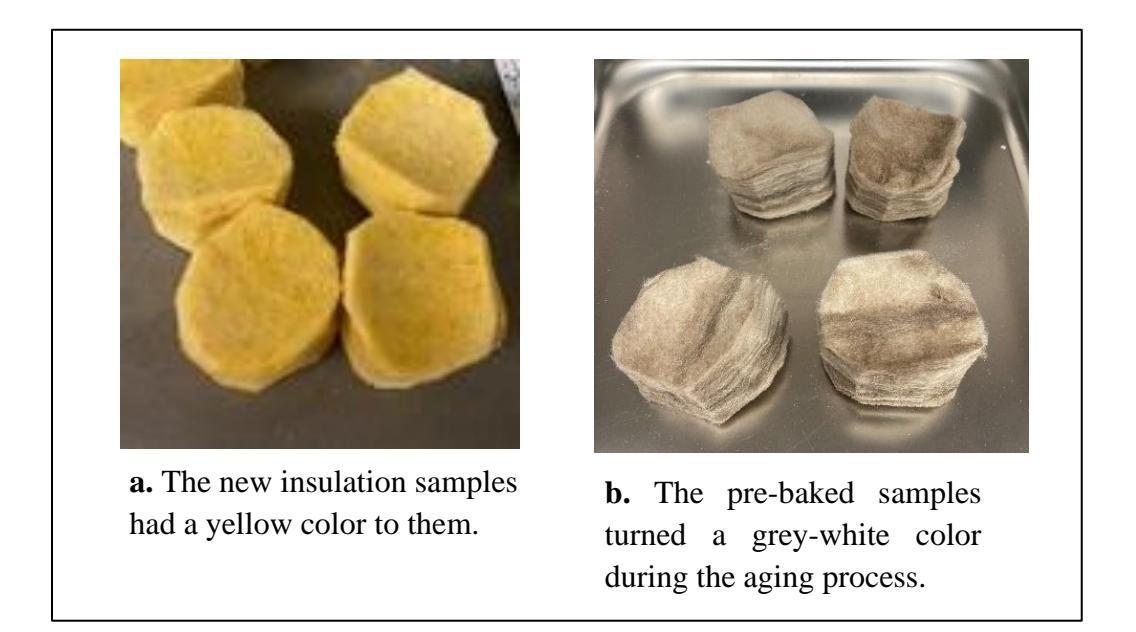
Figure 28. Comparison between the new insulation and pre-baked insulation.

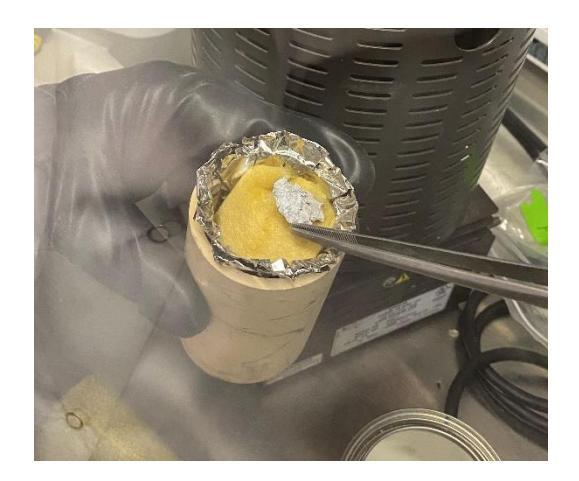
Figure 29. Depiction of the tests performed by placing the sodium on top of the insulation sample and seeing if ingression occurs during heating. After each test, the sodium would easily peel away from the surface of the insulation, indicating no ingression occurred.

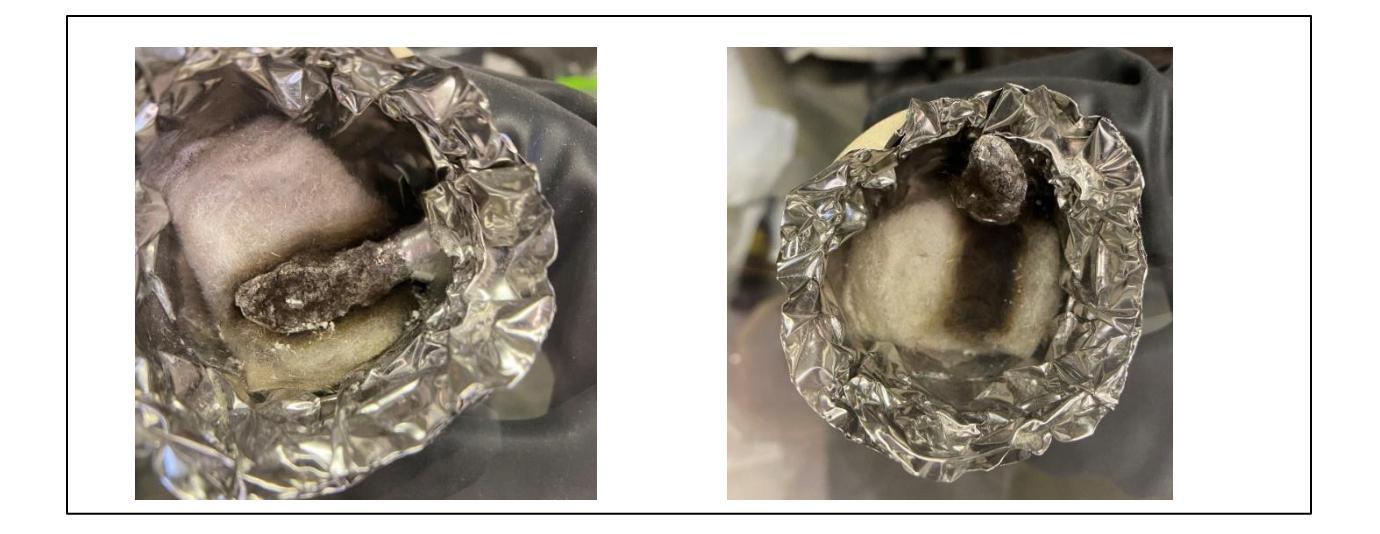
Figure 30. During the sandwich method, at temperatures of 300 °C and higher, the insulation began to blacken and degrade in locations directly contacting the sodium.

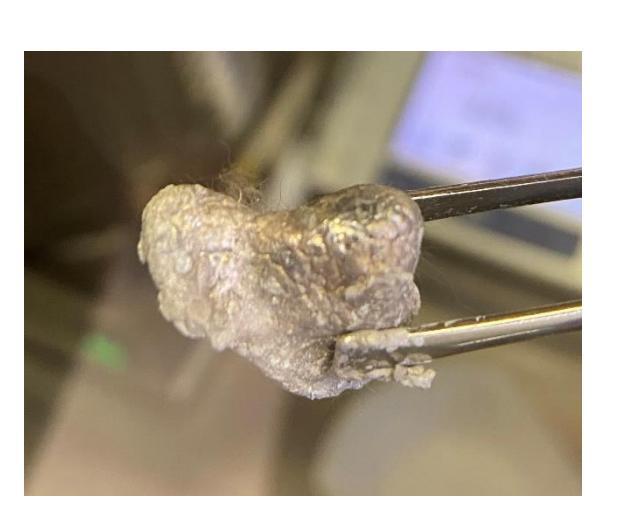
b. The sodium that was beneath the surface of the insulation inside the hole appeared to be unoxidized.

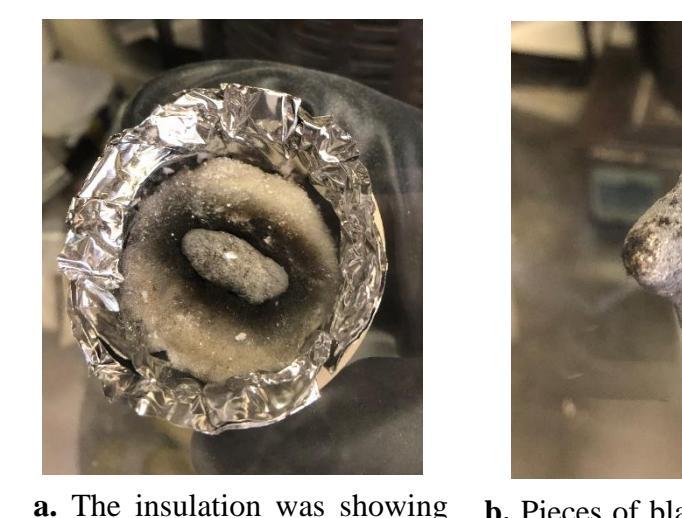
a. The insulation was showing signs of discoloration around location of the sodium.

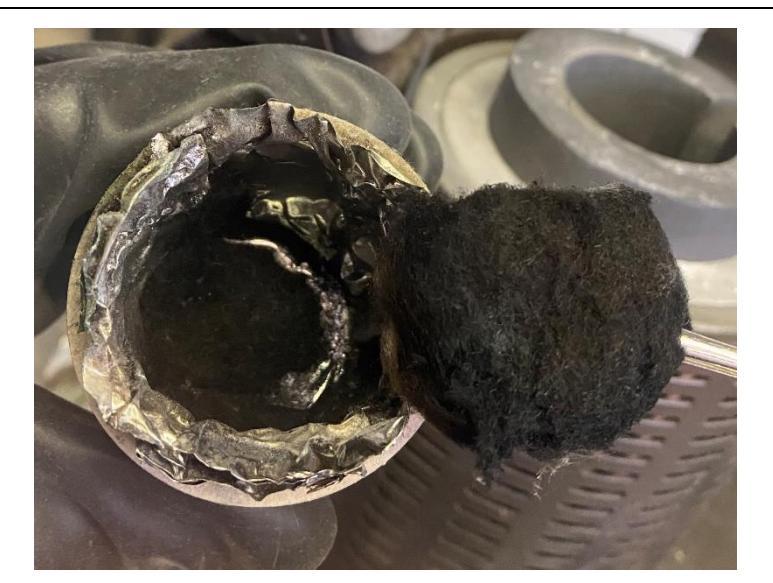
a. The recovered sodium was covered by small bits of insulation that had broken off during testing. The bottom of the insulation that was in direct contact with the sodium was very brittle and blackened.

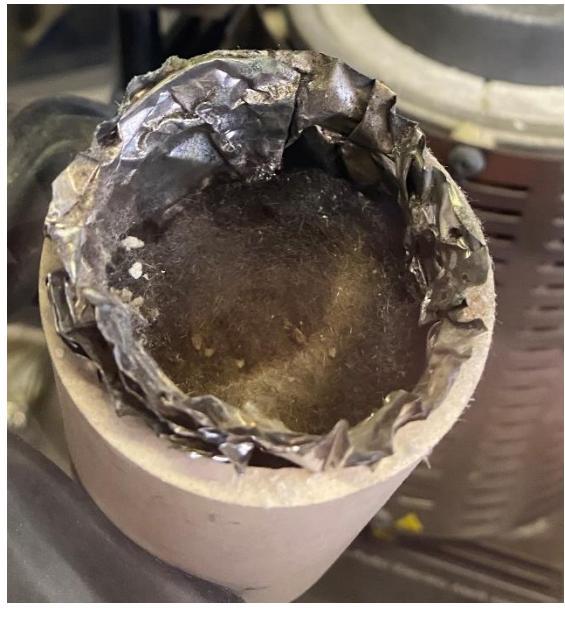
b. The top of the insulation was blackened, but not as degraded as the insulation in direct contact with the sodium.

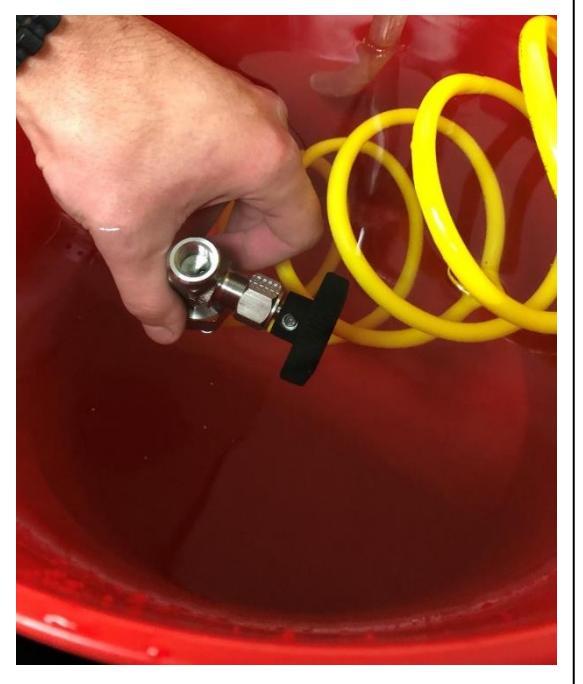
d. Pressurized parts were submerged under water and observed for bubbles.

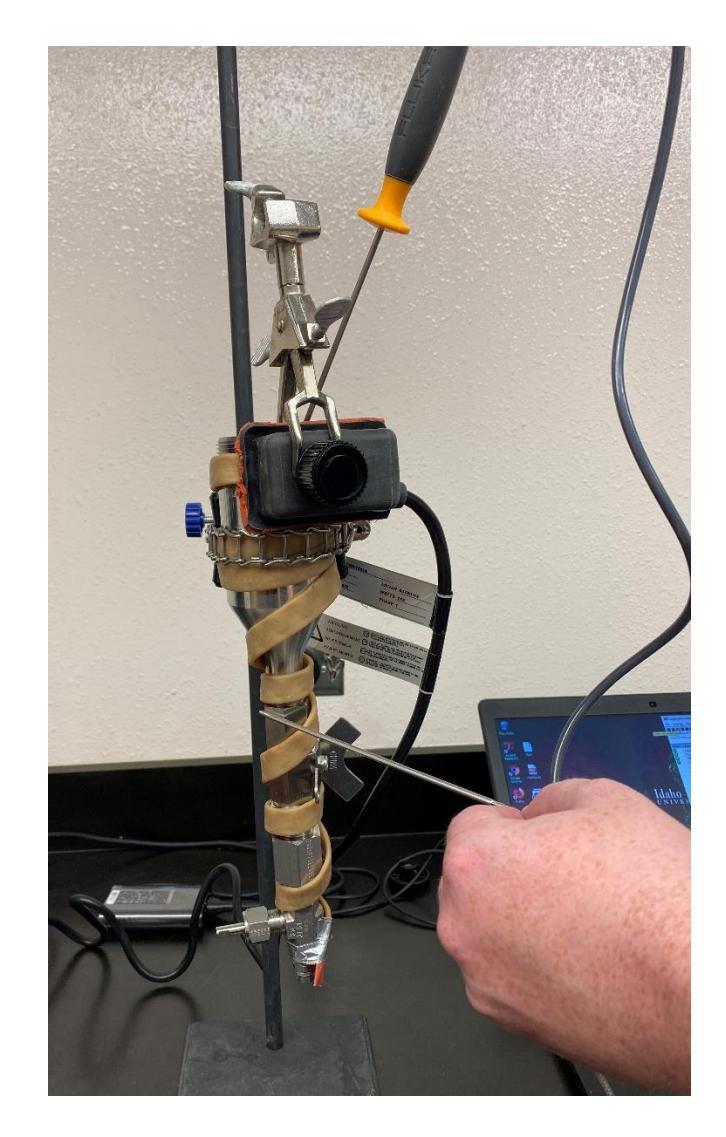
Figure 36. Heat tape being tested on the apparatus. The temperature control box was secured to the top of the vessel with a clamp, ensuring good contact with the vessel surface. Two thermocouples can be seen, one on the inside surface of the vessel, and the other being placed on the outside surface of the ball valve.
